BEECHWOOD LAKE DAM

NDS ID NO. PA-37

PHASE I INSPECTION REPORT
NATIONAL DAM INSPECTION PROGRAM

NAME OF DAM: Beechwood Lake Dam
STATE LOCATED: Pennsylvania
COUNTY LOCATED: Tioga
STREAM: East Beech Woods of Mill Creek
DATE OF INSPECTION: June 27, 1979

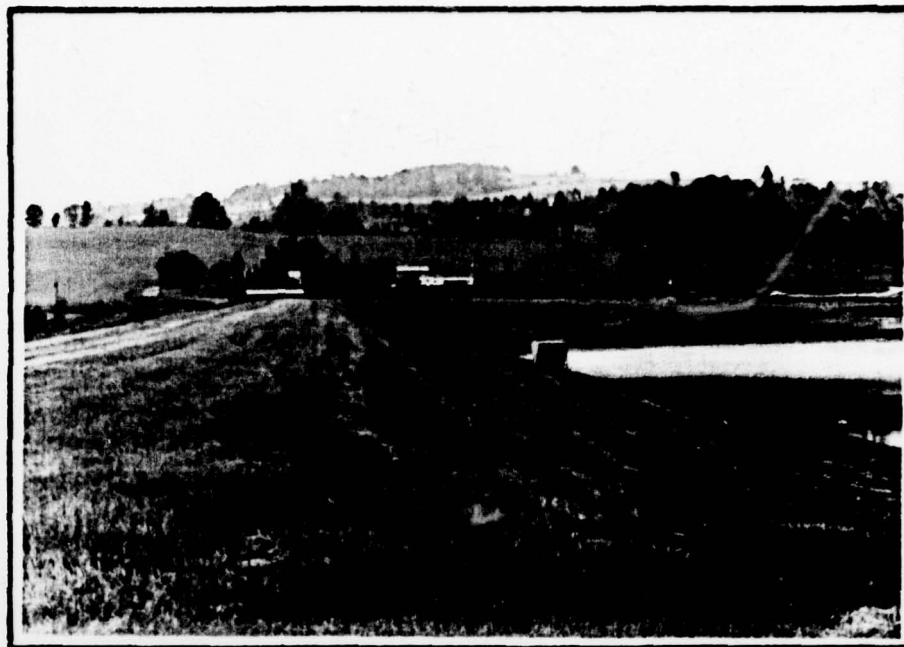
Overview of crest of dam and upstream slope.

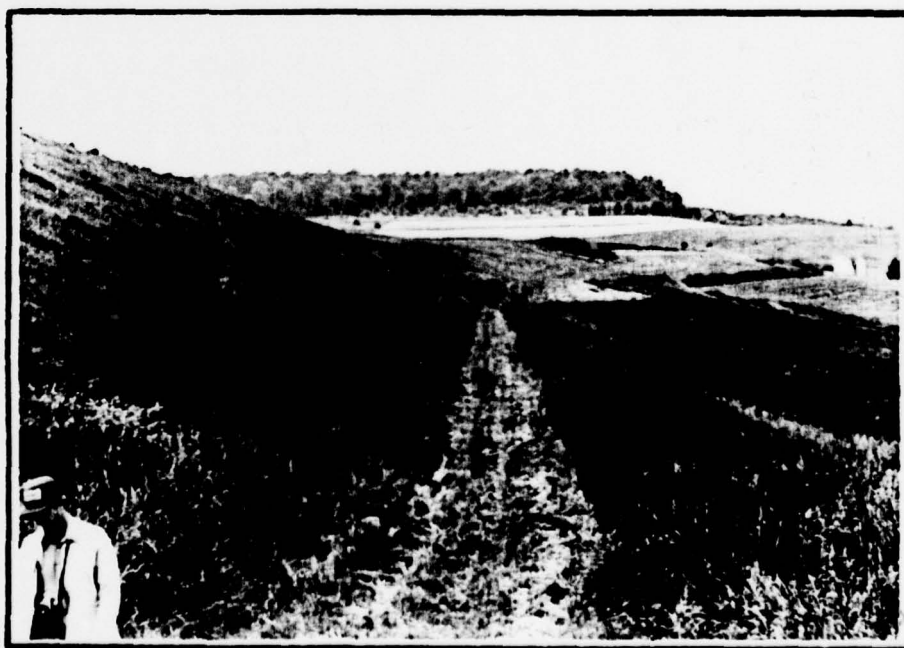
Downstream slope of dam.

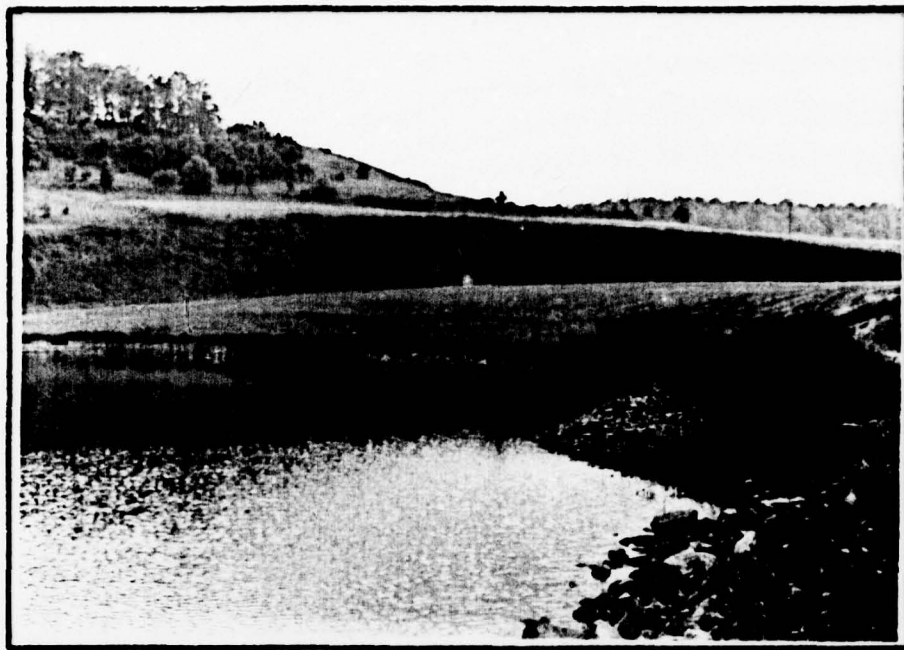
Spillway approach channel.

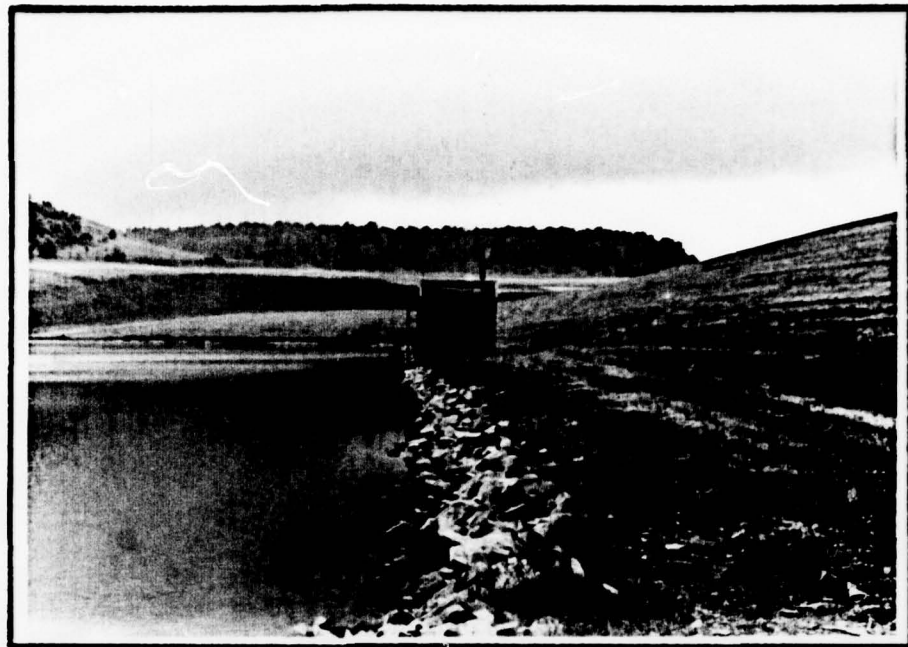
Principal spillway, orifice invert and
drain line structure.

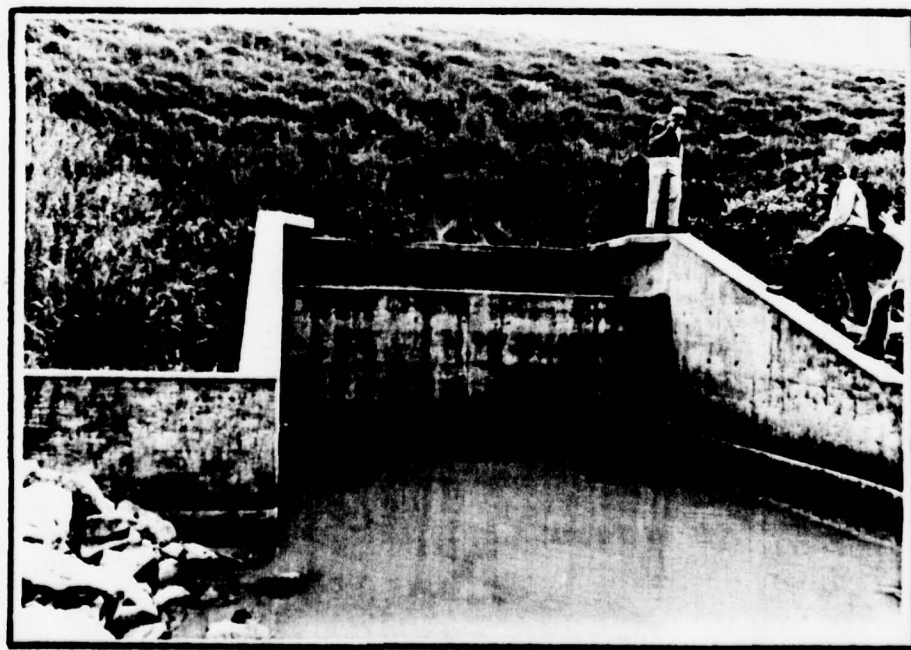
Impact basin at toe of dam.

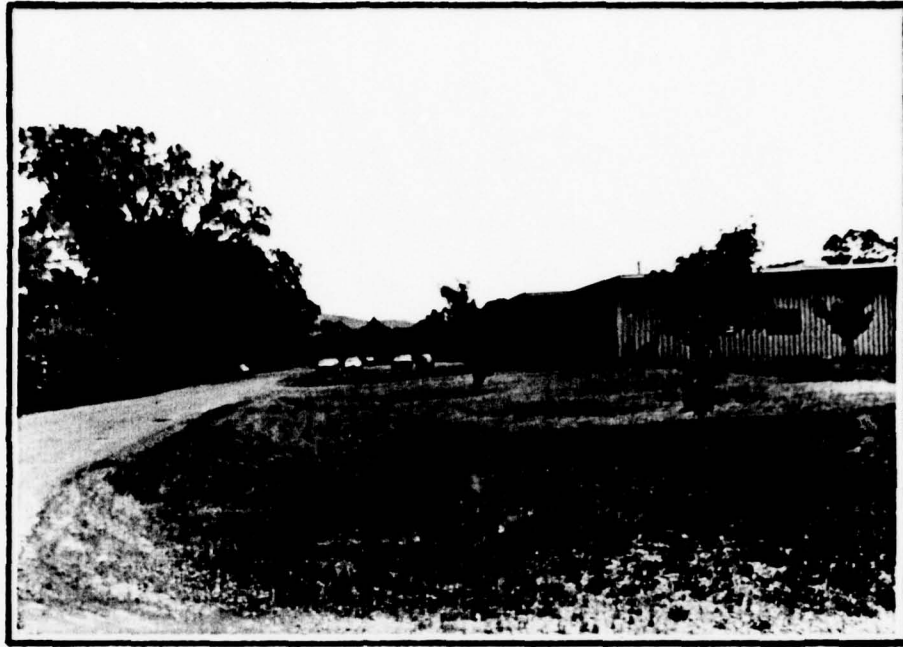
Clothing factory downstream of dam.

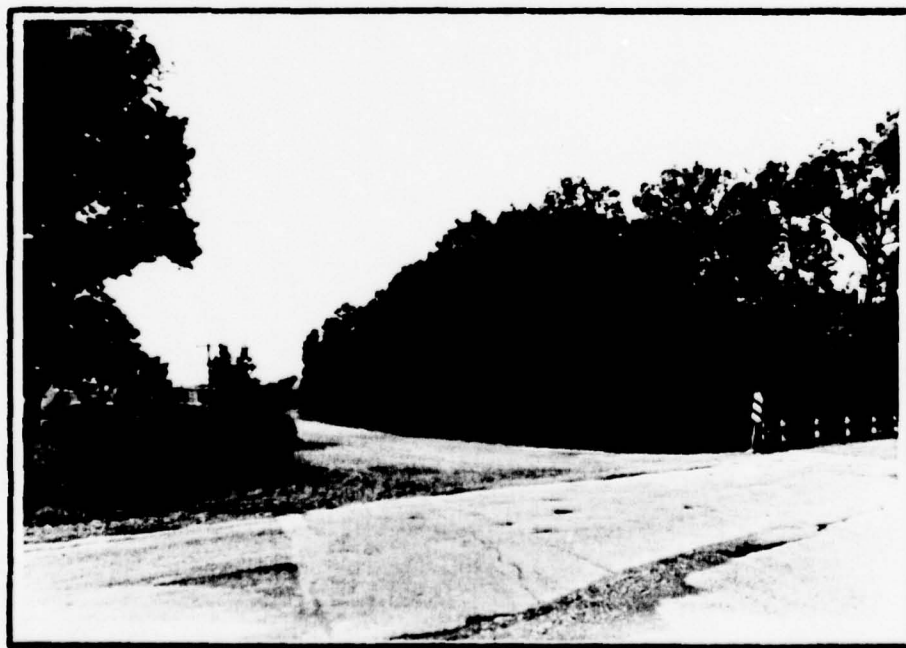
Business downstream of dam.
